## Low River Downs CVEA Structure

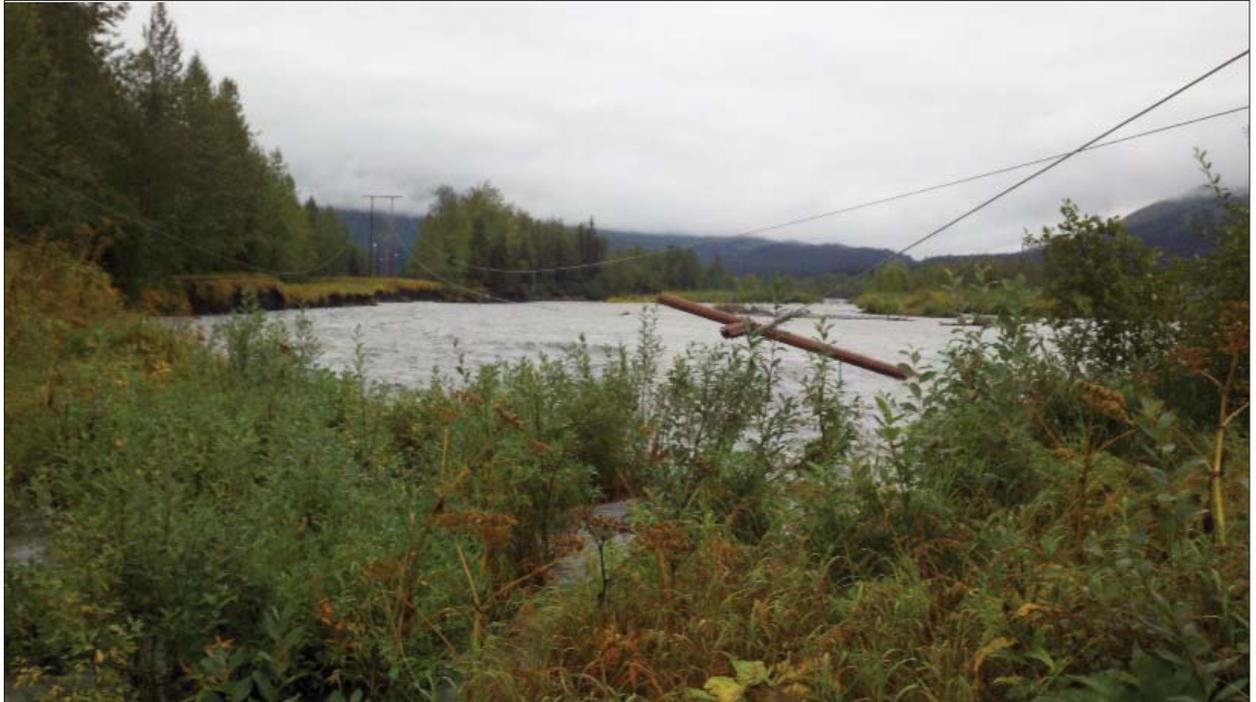
A crossarm dangles above the Lowe River in the area where Structure 38-7 stood prior to being destroyed by the Lowe River

After investigation it was determined the transmission line had been knocked out of service when Structure 38-7, west of Heiden View, was destroyed. Flooding changed the path of the Lowe River, eroded the land surrounding the structure, and caused the structure to collapse, leaving the crossarm dangling above the river.

In this case, the structure was washed out by the river and was pulled downstream with the wires still connected to the cross-arm by the insulators and hardware.

When the structure collapsed, CVEA's automatic protection systems opened the circuit breaker between Glennallen and Valdez to isolate the fault, as intended, resulting in a loss of power to members in the affected area.

Once power was restored to the majority of members, the CVEA team began to evaluate permanent and temporary solutions, carefully considering incremental fuel costs associated with running the Glennallen Diesel Plant, safety of the construction crews, and costs of construction and materials. It was ultimately decided that a temporary structure was the most efficient way to restore the line.

Immediately, CVEA engineered solutions and began moving forward; working closely with contractors, Alyeska, and the State of Alaska. The temporary structure was in place and the transmission line back in service within six days.

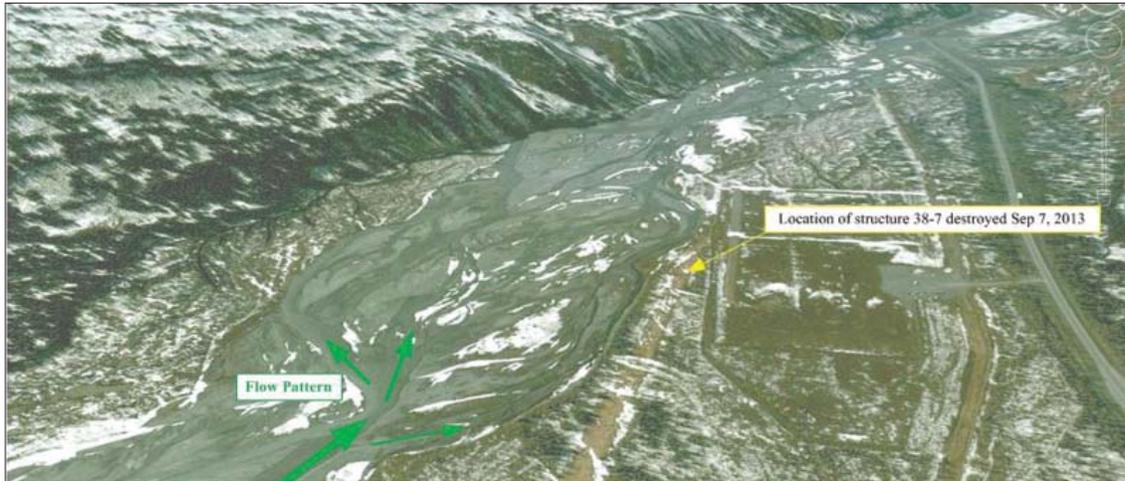
Top Left, satellite imagery of area surrounding Structure 38-7 from May 2004

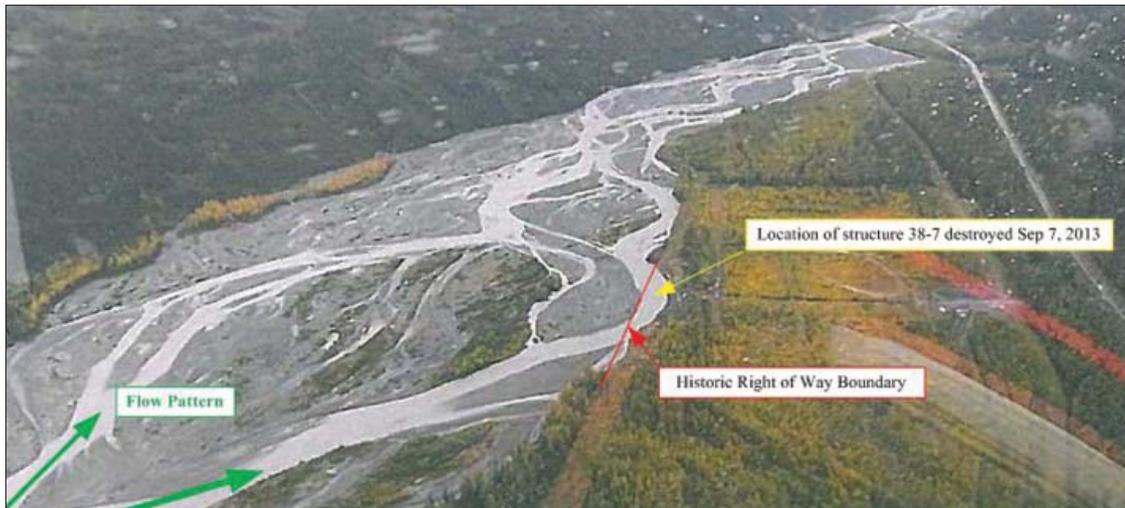
Middle Left, satellite imagery from September 2013 demonstrating the change in the Lowe River

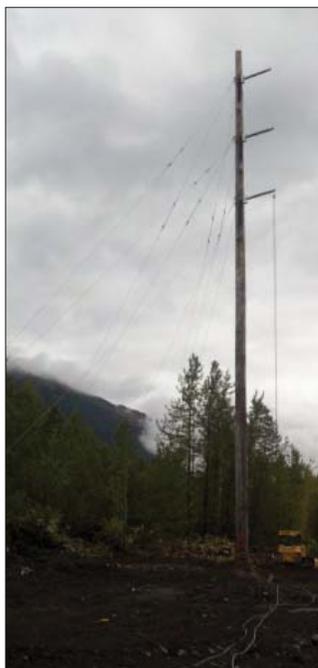
Bottom Left, a temporary structure was put in place to restore the T-line while developing a permanent solution

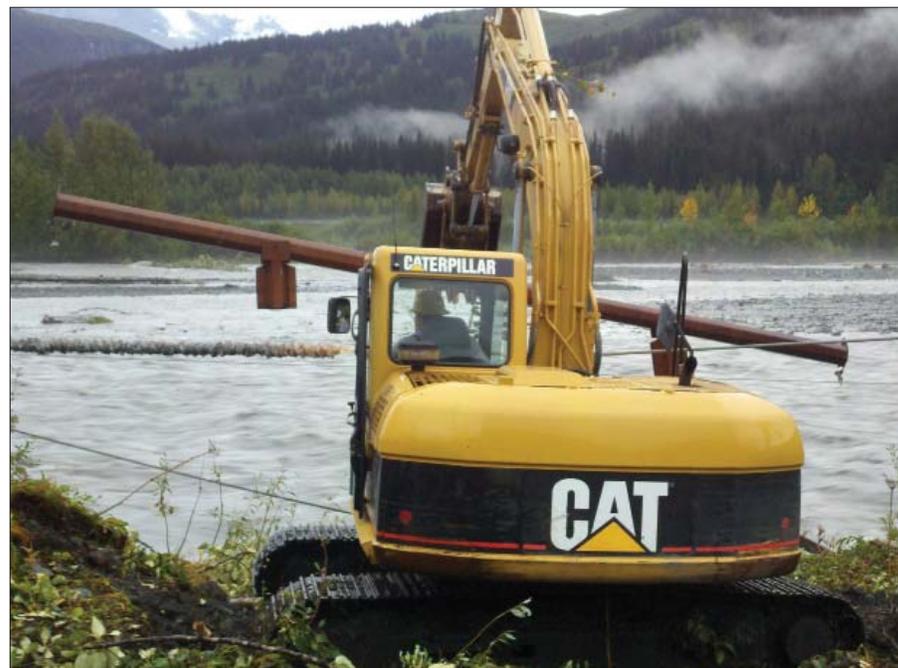
Bottom Right, heavy equipment was used to recover the crossarm from the Lowe River
