Allison Creek Hydroelectric Project 2015 Construction Update

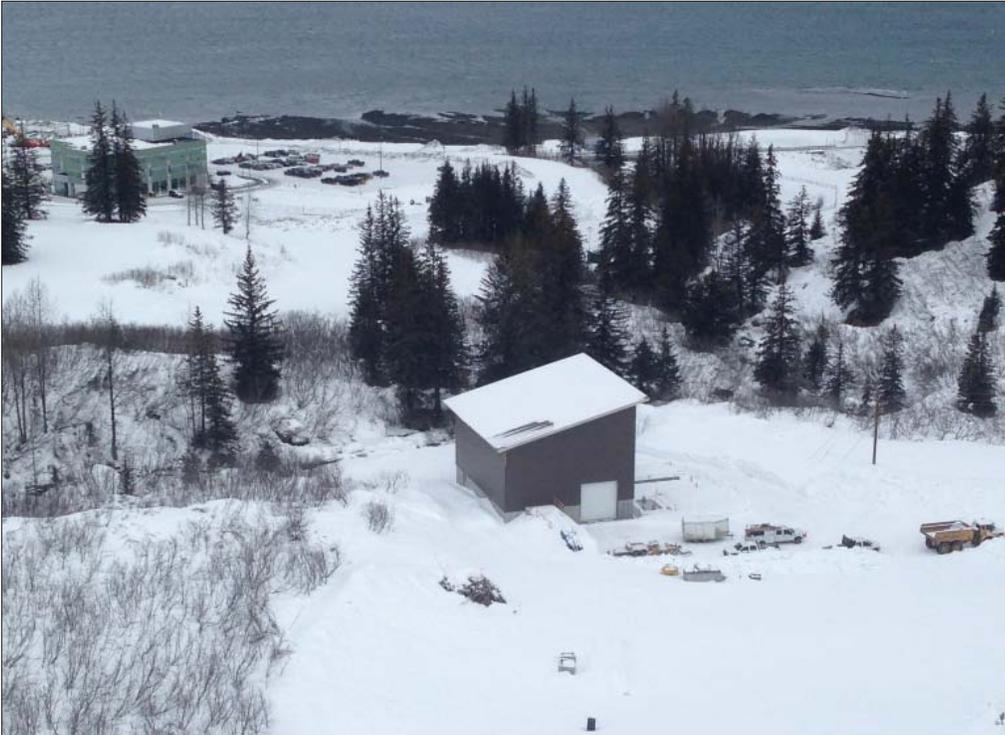
The newly constructed Allison Creek Power Plant in early spring

One of the most important accomplishments in 2014 was the construction of the powerhouse building. The powerhouse had to be constructed tall enough to pick up the turbine housing and lift it to its final position.

The building consists of very strong steel beams that are able to withstand the weight of a crane designed to pick up the extremely heavy turbine and generator. Attached to the beams are insulated, fabricated walls that were engineered specifically for Valdez weather and seismic conditions.

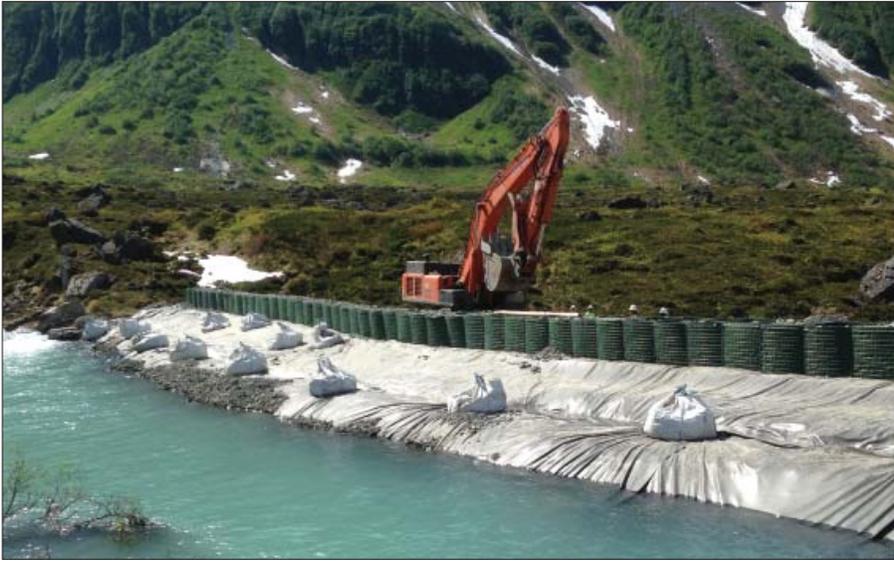
Top left, cofferdam behind the diversion dike at the intake area

ment walls, the foundation, forms, and rebar for the emergency generator building, and completed construction of the coffer dam behind the diversion dike at the intake area. This will channel water from the area, serve as a barrier, and keep debris from entering the water while the diversion structure is being built.

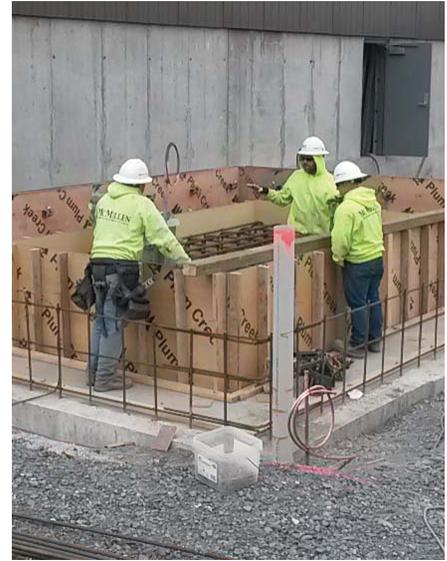
Top right, crews building the transformer pad and containment walls

Crews have also worked on the transformer pad and contain-

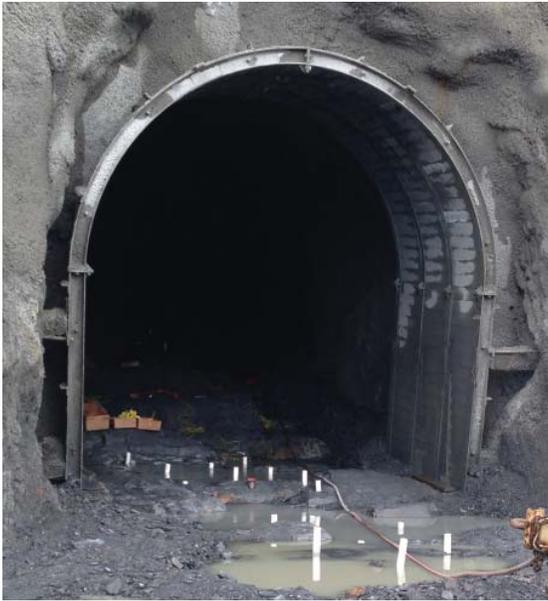
Far left, preparations for blasting the penstock trench inside the tunnel

Blasting for the penstock trench inside the tunnel started in April and continued through mid June. Penstock will be placed in the trench, covered in bedding material, and completely encased in concrete for protection.

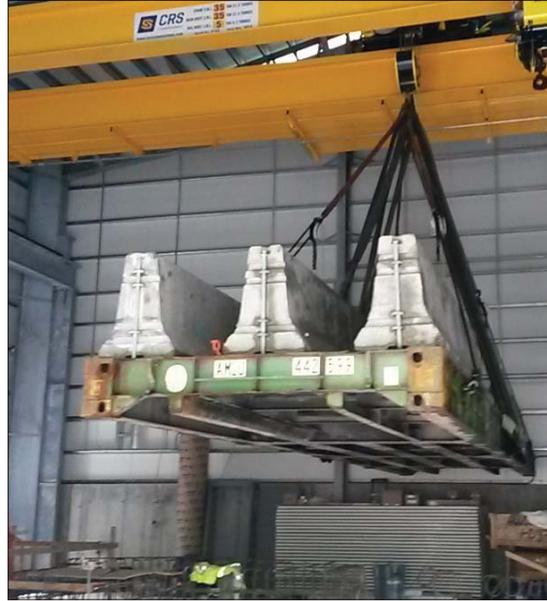
Left, 35 ton overhead bridge crane during testing

The 35 ton crane was successfully installed and tested to 125 percent of the safety margin in early June. This will allow for installation of the pelton housing, pelton and generator; which were completed and assembled in the factory, tested, and sent to Valdez last year, where they are now stored awaiting installation later this summer.
